Effect Analysis of Soil Saturation and Slope Angle on the Geotechnical Stability of an Engineered Soil Slope – Bir Al-Ghanam Road, Libya

Aboalgasem Alakhdar

Geological Engineering Department, Faculty of Engineering, Jadu, Nalut University, Libya

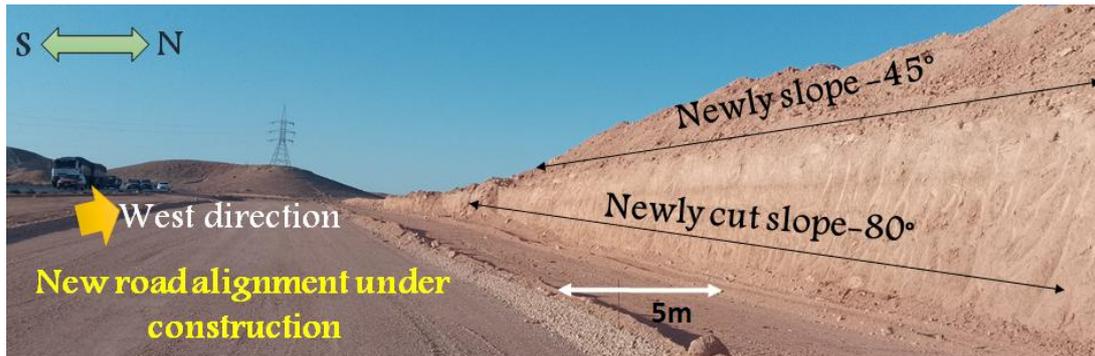
In the study area, the construction of a new road parallel to the existing road led to the removal of parts of the natural slopes and the creation of a steep engineered slope (Figure 1). The angle of the new slope ranged from 70–90°, with an average of approximately 80°, within a soil stratum consisting of a cohesive lower layer overlaid by an uncohesive upper layer composed of poorly cohesive silty, crumbly, and clayey materials. Clear signs of water erosion were also observed on the surfaces of adjacent slopes, particularly gully erosion, reflecting the pivotal role of water saturation in accelerating geotechnical degradation mechanisms. These processes lead to a decrease in the shear strength of clayey

Figure 1: Section of cut slopes for road construction.

The horizontal displacement of the failed mass is estimated at approximately 7 m from the slope toe, derived from the trigonometric relationship associated with the 45° failure angle. Considering that the road is located 5 m from the slope toe Figure 1, the analysis indicates that the failed mass would reach and exceed the road by nearly 2 m in the event of full Failure. This clearly places the roadway within the direct impact zone of potential failure.

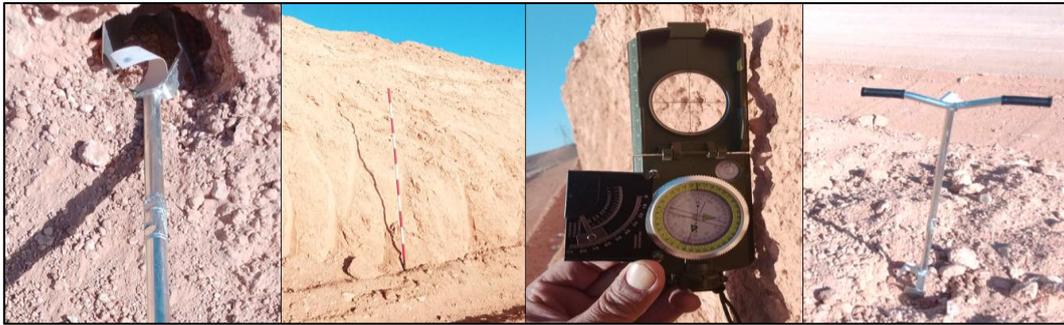
Fieldwork began on February 8, 2026, and continued for two days, using equipment and devices designed for fieldwork to collect data, describe the cut slope, determine the characteristics of the new slope geometry, and monitor field markers. The instruments used included a compass, geological hammer, Jacob's staff, magnifying glass, and various measuring rods Figure 3. Samples were also collected for laboratory study, and the most important data and measurements recorded in the field are listed in Table 1.

Figure 3: Fieldwork activities.

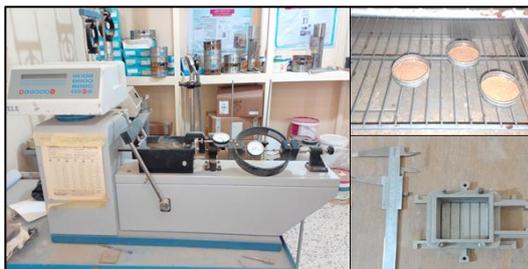
After collecting the sample from the location indicated in Figure 1, it was dried in an oven at 105°C for 24 hours to ensure complete removal of moisture Figure 4. In the next stage, 10 mm of water was added to the dry sample, which was then mixed thoroughly to ensure uniform water content throughout the sample. Vertical stress and shear stress tests were then performed using a direct shear tester at a constant loading rate of 0.25 mm/min [10] Figure 4. A loading frame with a constant area of 36 cm² was used for all tests, and the experiment was repeated under three different vertical weights of 4 kg, 8 kg, and 16 kg (Figure 5).

Figure 4: Direct shear test and sample preparation.

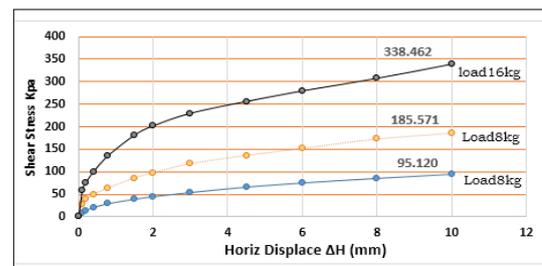
Figure 5: Variable vertical loading (4, 8, 16 kg).

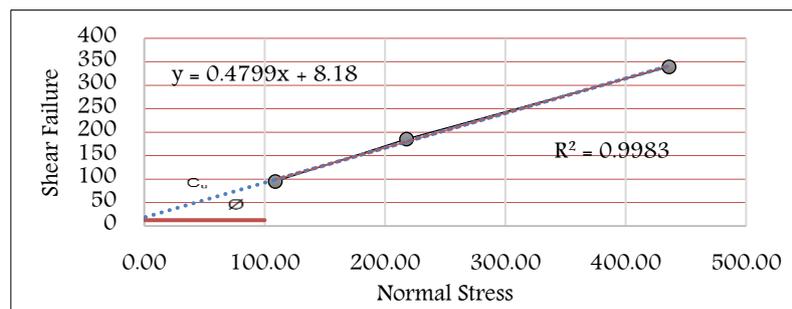
The analysis of the direct shear test results is based on the use of an Excel model to represent the linear relationship between vertical (normal) stress and shear stress, as shown in Figure 6. Through this relationship, the shear resistance coefficients, represented by the internal friction angle and cohesion, were calculated. Figure 6 shows the cohesion values when 50 mm of water is added, while Table (4) presents a comprehensive summary of the experimental data obtained from laboratory tests on soil samples at different water quantities of 10, 20, 30, and 50 mm.

Figure 6: Relationship between normal and shear stress at 48% saturation.

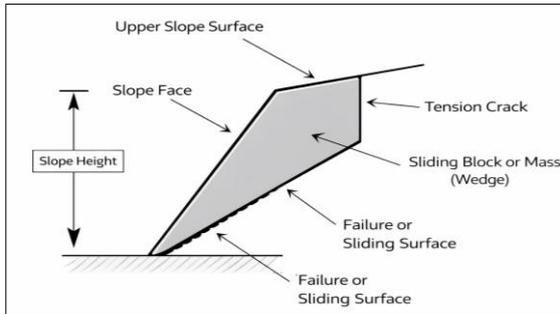
Figure 7 illustrates the field-derived inputs representing the slope geometry, including the slope face, upper slope surface, slope height, tension crack, sliding (wedge) block [13], and the failure (sliding) surface. These geometrical components form the basis for kinematic analysis and slope stability assessment (Figure 8). The most important slope geometry data entered into the program is obtained from fieldwork, Table 1.

Figure 7: Field-derived inputs representing slope geometry

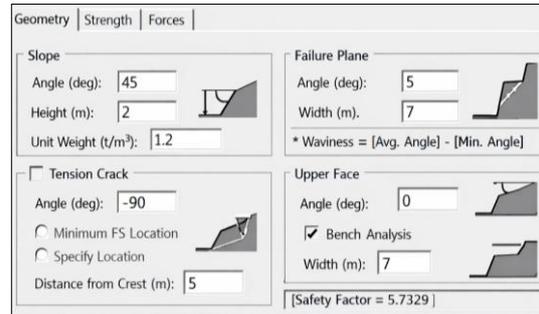
Figure 8: Inputs geometry slope [13].

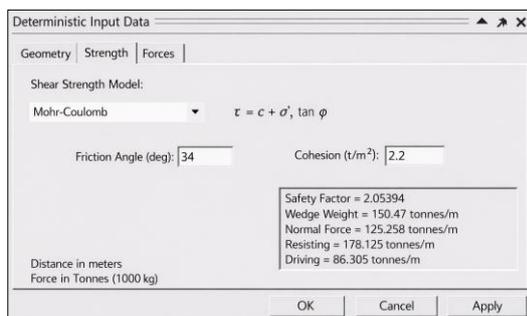
These parameters include values obtained from laboratory testing, namely the cohesion (C) and the internal friction angle (ϕ) of the rock material along the failure surface, as illustrated in Figure 9. These parameters were determined through controlled laboratory experiments, and their values were varied for each slope simulation case in order to evaluate the Effects of mechanical property variations on the factor of safety and overall slope stability under different conditions. These factors include the driving forces that initiate movement, such as pore water pressure within rock fractures, in addition to the effects of seismic loading. The seismic effect was represented using a seismic coefficient of 0.04, based on the regional seismic characteristics of the study area (Figure 10).

Figure 9: Shear strength inputs (C) & (ϕ) [13].

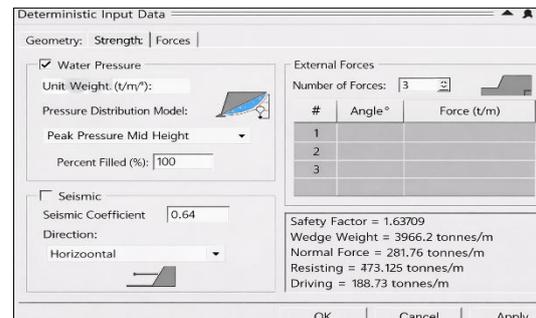
Figure 10: External factors [13].

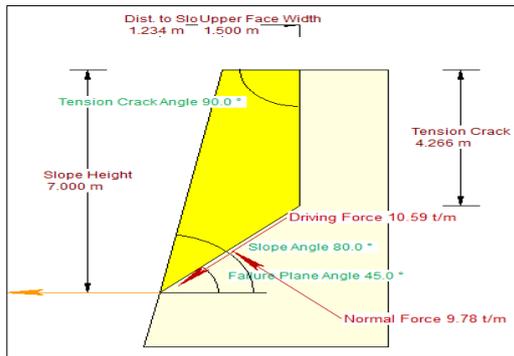
Figure 11: Slope simulated at 25% saturation

In cases 1 and 2, corresponding to water inputs of 10 and 20 mm, the water content increased from 6% to 8%, and the degree of saturation rose from 25% to 32%. This led to a slight reduction in cohesion, from 10.4 to 9.8 t/m², and in the internal friction angle, from 32° to 30°, reflecting a minor decrease in shear strength. Despite this reduction, the values remained relatively high due to the granular nature of the gravelly soil with clay fraction, which maintains substantial shear resistance. The dry density increased from 1.3 to 1.5 t/m³, likely due to partial wetting and rearrangement of the soil grains, which improved particle interlock temporarily. Numerical analysis revealed no significant pore water pressure (Water Peak Pressure not present) Figures 11 and 12, indicating that the vertical stress remained largely effective. Vertical forces reached 9.779 and 11.284 t/m for cases 1 and 2, respectively, while the resisting forces were 46.326 and 44.410 t/m, compared to driving forces of 10.594 and 12.224 t/m. The large differences between resisting and driving forces resulted in high safety factors of 4.37 and 3.63, confirming the slope's extremely high stability under low saturation conditions.

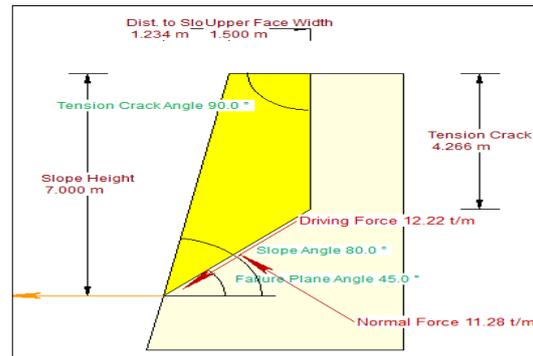
Figure 12: Slope simulated at 32% saturation

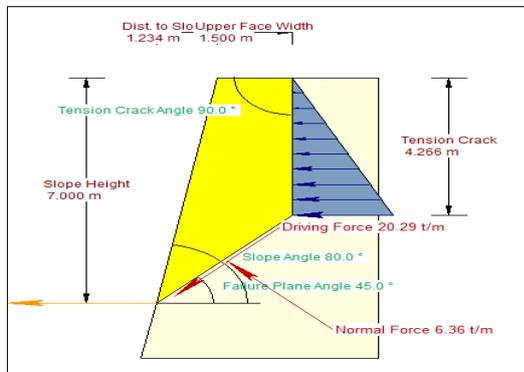
Figure 13: Slope simulated at 30% saturation

In cases 3 and 4, at water quantities of 30 mm and 50 mm, the figures show a more pronounced change compared to the previous cases. The water content increased from 10% in case 3 to 12% in case 4, while the degree of saturation rose from 40% to 48%. At the same time, cohesion decreased from 8.5 to 8.1 tons/m², and the internal friction angle dropped from 28° to 25.6°, representing a significant reduction compared to earlier cases. At this stage, peak pore water pressure appeared. In case 3, it was concentrated at the slope base Figure 13, whereas in case 4, it shifted to the mid-height of the slope Figure 14, indicating the development of a saturation front within the soil mass. As a result, the vertical force increased to 6.355 tons/m in case 3, then decreased to 2.235 tons/m in case 4, reflecting the effect of pore pressure in reducing effective stress. The resisting force also decreased from 36.247 tons/m in case 3 to 32.393 tons/m in case 4, while the driving force remained relatively high at 20.288 tons/m and 20.688 tons/m, respectively. This convergence between resisting and driving forces led to a notable decrease in the factor of safety, from 1.79 in case 3 to 1.57 in case 4

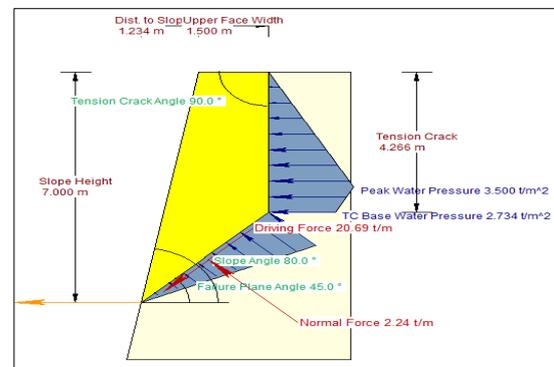
Figure 14: Slope simulated at 25% saturation

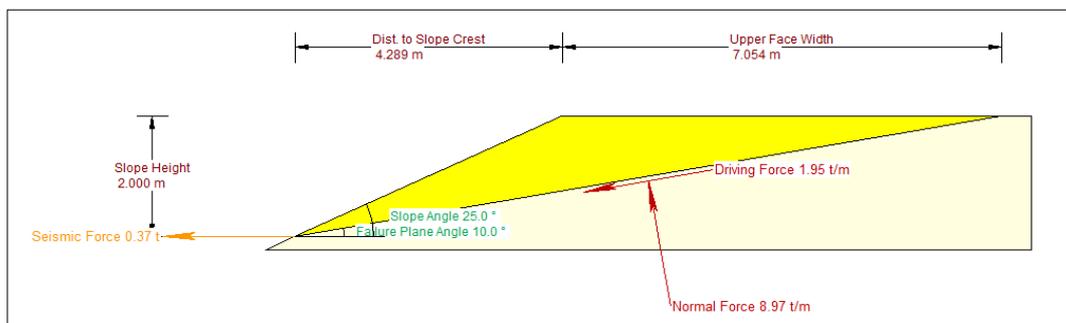
In Case 1 (10 mm), the safety factor before modification was high (4.37), indicating a stable slope under semi-dry conditions. After the geometric modification, the safety factor increased dramatically to 64.19, which cannot be attributed to changes in soil properties, as cohesion and internal friction remained constant, but rather to the redistribution of forces due to the slope flattening. The driving (shear) force decreased from 10.59 to 1.95 tons/m (82%), while the resisting force increased from 46.33 to 125.39 tons/m, significantly improving the ratio of resisting to driving forces. Mechanically, reducing the slope angle lowers the shear component of the weight while enhancing the effect of vertical stresses in resisting slip. Figure 15 illustrates the slope simulation after the geometric modification.

Figure 15: Simulation of the modified slope in case 1

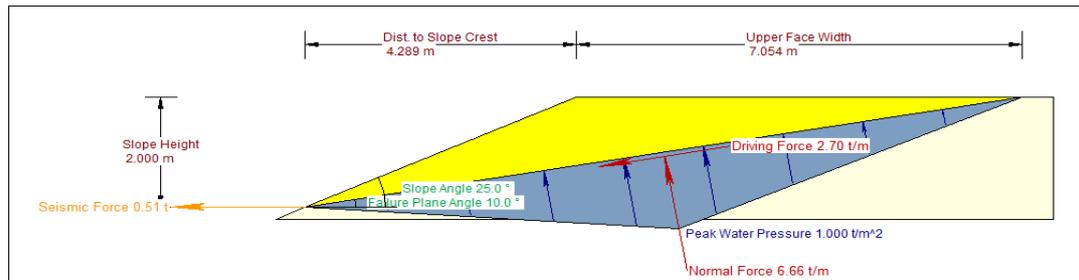
In Case 4 (50 mm), which was critical before modification due to the development of pore water pressure and a low safety factor of 1.57, the modified slope showed remarkable improvement, with the safety factor rising to 35.67. The

driving force decreased from 20.69 to 2.70 tons/m (87%), while the resisting force increased from 32.39 to 96.48 tons/m. Vertical stress also increased from 2.24 to 6.66 tons/m, reflecting an improvement in the effective stress along the slip surface. This demonstrates that the original instability was primarily controlled by pore water pressure, reducing the effective normal stress and weakening shear resistance. By reducing the slope angle, the driving-to-resisting force ratio was drastically lowered, making the system less sensitive to pore pressure effects. Figure 16 illustrates the slope simulation under these conditions.

Figure 16: Simulation of the modified slope in case 4 under pore water pressure effect
